JSACE 1/24

Low Energy Consumption Façade Pilot Project

Karlis Bumanis, Karlis Pugovics*

Forest and Wood Research and Development Institute, Latvia

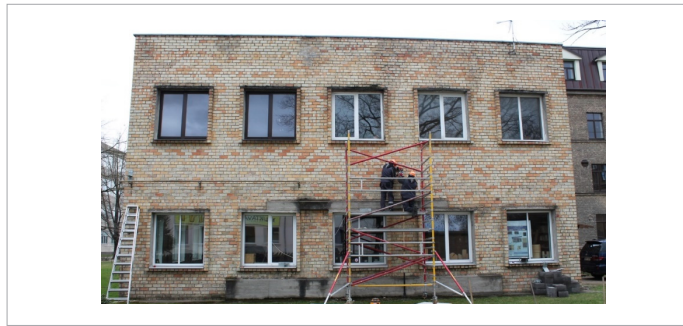
Fig. 1

The façade had three major aspects that caused additional problem solving during the design phase, first being brick and concrete window casings around each of the 10 windows (see Fig. 1), second – reinforced concrete reinforcing elements constructed later in order to support testing equipment and third being an open gas line protruding about 300 mm from the existing façade.

The façade in question, built in the 1970's, note the window casings, reinforced concrete elements and gas line

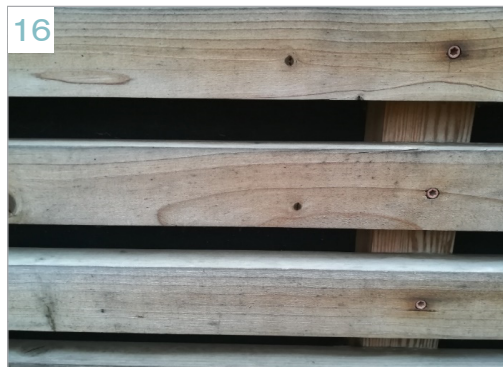
Fig. 16

- _ Fungal development on thermally modified cladding (see Fig. 16).
- _ Discoloration around fixing element on thermally modified timber cladding (see Fig. 17)
- _ Fungal development and delamination of cladding elements, treated with white, semi-transparent façade paint (see Fig. 18 and 19)
- _ Discoloration of thermally modified cladding elements (see Fig. 20).

The fungal development in thermally modified cladding elements can be explained with possi-

Fungal development at around 1400 mm from ground level as observed on November, 2018

ble shortcoming in the thermal modification process, however more aggressive thermal modification would compromise the structural integrity of the cladding member, thus rendering it unusable in this application, for this a cladding member with greater dimensions should be considered, however this would not be feasible due to economic aspect, so some form of translucent oil treatment should be considered in order to preserve the thermally modified timber cladding elements.

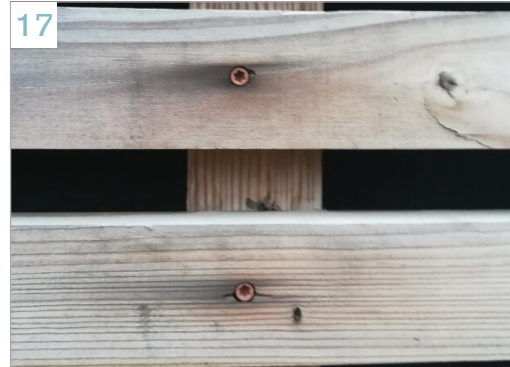
Fig. 17

Discoloration around fixing element on thermally modified timber cladding as observed on November, 2018

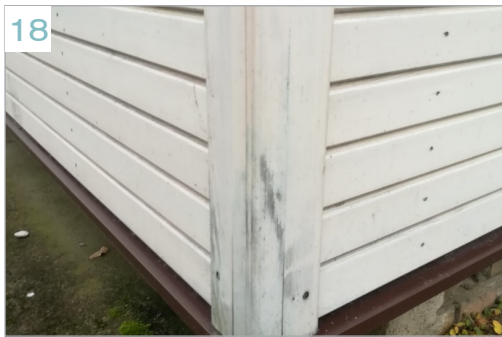
Fig. 18

Delamination of the larger cladding elements, covering corners and panel gaps can mainly be attributed to dimensions of the cladding element, while fungal development in the corner (see Fig. 18) is most likely due to incorrect execution of element fixing – the timber element is touching the metal drainage element, which makes it more susceptible to damage caused by excessive moisture.

Fungal development and delamination of timber cladding elements at around 200 mm from ground level as observed on November, 2018

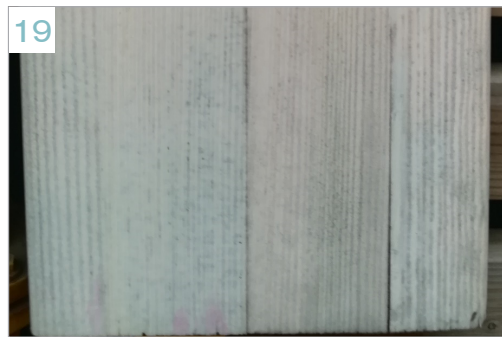
Fig. 19

Delamination of timber cladding element at around 1400 mm from ground level as observed on November, 2018

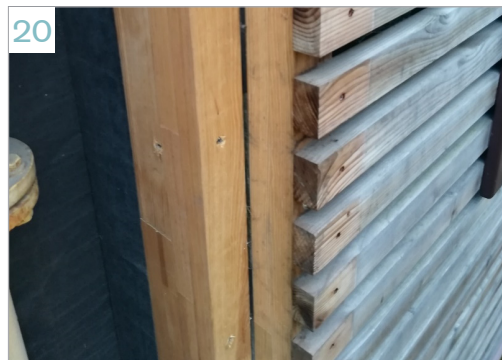
Fig. 20

Fungal development and discoloration of thermally modified cladding material suggests problems with untreated thermally modified timber caused by factors to be researched further on.

Discoloration of thermally modified cladding elements is clearly visible, when removing cladding part, covering the gas line as observed on November, 2018, note the lack of discoloration around fixing elements
