Technical State, Renovation Need and Performance of Renovation Solutions of Estonian Wooden Log Houses

Journal of Sustainable
Architecture and Civil Engineering
Vol. 1 / No. 34 / 2024
pp. 35-52
DOI 10.5755/j01.sace.34.1.35606

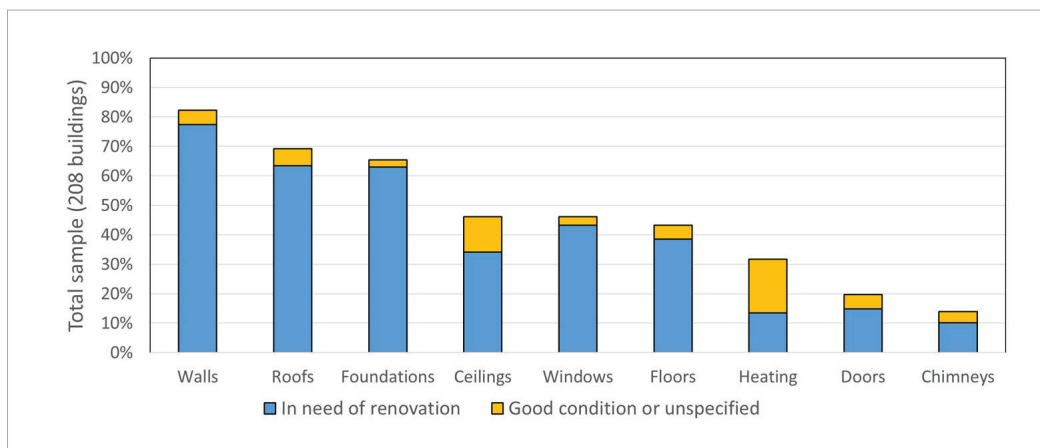
Fig. 2

Wall, roof, and foundation were structures most frequently mentioned in survey as needed to be renovated (Fig. 2). A number of structures within the database described a good condition or did not provide details concerning renovation need. Structures concerning heating were highlighted as well, yet due to low level of detailed data, these were excluded from further analysis in the current study. Barn-dwellings were mentioned more in all structure categories, which indicates more vulnerable structures and a greater need for renovation comparing to common detached houses. Another explanation for this is the older age of the barn-dwellings. Our findings are supported by Dutu et al. (2023), who showed that the most of the damage and degradations that occur in almost all traditional timber houses are related to water infiltrations and humidity – the wall, roof and foundation are in contact with the highest moisture loads. Although houses with a different basic typology, these structures have been determined also by other studies to be the most vulnerable. Nowogońska & Mielczarek (2021) studied abandonment of renovations and found that the most urgent renovation works are the renovation of the foundations and walls. Lourenço et al. (2006) presented the need to renovate the roof or facade due to water seepage and condensation in buildings from historical city centres in Portugal. In Norway (Risholt et al., 2013), the foundation was also one of the most defective building elements, but wet rooms and windows replaced the roof and exterior wall in acute need for renovation. In Finland serious damage from moisture has been found in 82 % of detached houses (mainly wooden) built since the 1950s, concentrated to wet areas, base floor structures and the joints between the base floor and wall structures (Heikkilä, 2005). Therefore, building surveying and renovation measures should always be carried out to structures that can be in contact with excess humidity. The current study, however, does not include detailed information concerning wet rooms due to low occurrence among the studied buildings or lack of focus among consultants on such structures. The walls, roof and foundation, are also structures that should be renovated to minimize heat loss (Alev et al., 2014). Thus, by combining the two goals in renovation of buildings, it is possible to get a double benefit. Fig. 3 and Fig. 4 presents the locations and reasons for damages and renovation need, described in detail in following chapters.

Frequency of consulted structures and corresponding renovation need included in consultation reports of 208 examined houses

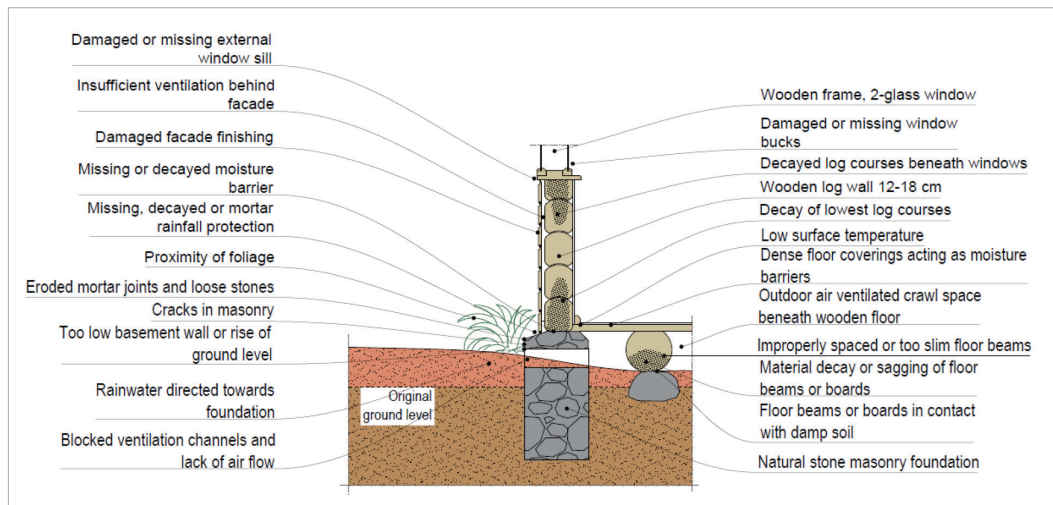
Fig. 3

Typical connection detail of external wall, foundation, and floor with typical damages and renovation needs

The three most common types of damages among natural stone foundations, present in 71 % of foundation reports, were: crumbled mortar joints (51 %), cracks in the masonry (25 %), and loose stones (13 %) (Fig. 3, Fig. 5 above). Causes for these damages were related to rainwater degradation (which will increase in future during winter (Bonazza et al., 2009)), insects (for example, ants) and natural weathering from passage of time. Wet masonry is also in risk of eroding due to freeze-thaw cycles in cold climates (Grossi et al., 2007). The introduction of moisture can be due to precipitations, where the lack of a functioning rainfall protector (highlighted in 37 % of foundation reports), insufficient foundation wall height (38 %) and ground slopes directing rainwater towards

The most common damages of floors were related to material decay (31 %), sagging (22 %), or a general end of service life (6 %) (Fig. 3, Fig. 5 below). Problems related to the thermal comfort (such as low floor temperatures) of residents were occasionally highlighted as well. The common cause of material decay was excess moisture resulting in fungus growth, and insect damage. The leading causes of excess moisture were related to unventilated moisture evaporating from the ground and wooden beams or -boards in direct contact with damp soil.

Problems concerning original windows generally included material decay of the wooden frames and large air leakage through the window structure. 45 % of window reports highlighted a conservation potential for the existing windows (durability of frame), while 21 % were declared to be at the end of the window's service life and in need of immediate replacement. From experience of the authors, wood window frames can decay from use and climate load during its long use period and poor material quality and airtightness. Concerning the structure surrounding the windows, damaged or missing window bucks were highlighted (16 %), as either an oversight made during the time of construction or mistakes made during previous repair works (for example, widening existing windows or making new window openings). Missing bucks can lead to lower stability of the surrounding log wall. Windowsills were mentioned in 15 % of window reports, highlighted to be either damaged or missing (Fig. 3).

In order to eliminate foundations damages, the consultants have recommended removing loose mortar joints and foundation stones before repairing or reconstructing the structure with appropriate lime-based materials. Repairing the rainfall protector generally concerned either installation, repair or replacement with a new wooden board with proper width and slope. This solution is not guaranteed to have an optimal service-life, however, as without additional flashing or other covering, the wood element will begin to decay yet again. Mortar-based rainfall protectors were all recommended to be removed, as contact between mortar and wood elements ought to be avoided in foundations (Alev & Kalamees, 2016).

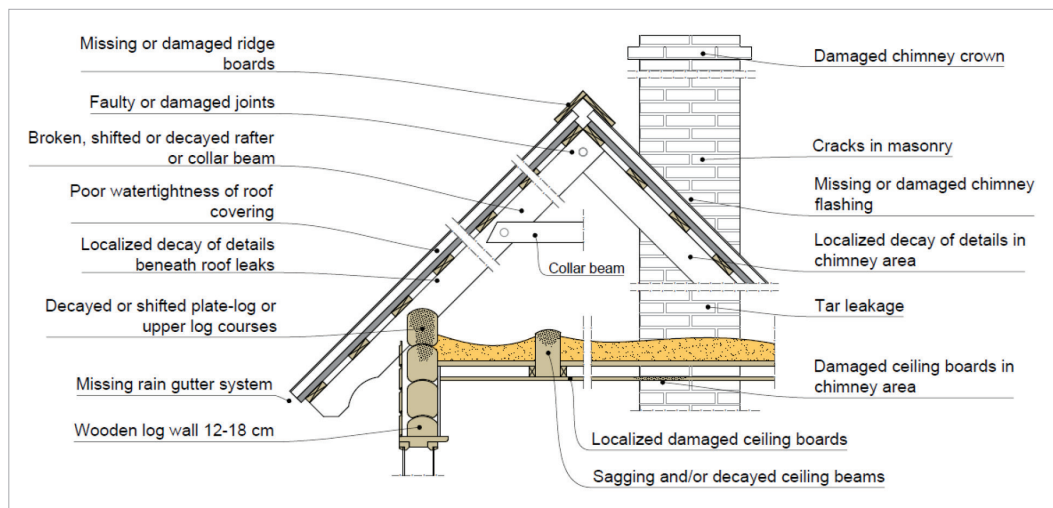
Fig. 4

Typical connection detail of external wall, roof, attic floor and with typical damages and renovation needs

All cases of damage in attic floors were found to be related to physical damages, such as sagging (not enough load bearing capacity) (26%) or material decay (Fig. 4). Material decay was highlighted in 58 % of reports, related to either excess moisture and resulting fungus growth or insect damage. The specified cause for excess moisture was generally roof leaks.

or missing rain gutter systems (18 %) were the most common roof renovation needs (Fig. 4, Fig. 6 below). The main cause was water infiltration from roof leaks or poor water tightness of flashing around penetrations like dormer, chimney, ventilation pipe, etc. The most common reasons for structural issues were faulty or damaged joints, broken rafters, rafters with insufficient dimensions or spacing, poor structural design, or demolition of load-bearing elements. A study of roof defects among Norwegian dwellings built between 1993 and 2003 highlighted leaky roof coverings or fittings as typical defect mechanisms (Gullbrekken et al., 2016). This is corroborated by another study of dry rot fungus prevalence in Norwegian buildings, where 94 % of material decay roof structures had been related to roof leaks (supplemented by moisture seepage) (Austigard et al., 2014). These damages generally occur from precipitations and climate exposure, which are likely accompanied by lack of roof maintenance or improper construction methods applied during roof installation. For example, missing or damaged roof elements in the study included ridge boards, chimney flashes and valley flashes, which left the roof structure vulnerable to precipitations.

As attic floor damages were generally related to roof damages, existing roof leaks were recommended to be repaired. In some cases, as the beams may not have been visible during the consultation, further investigations were recommended after the removal of ceiling or floor structure. Following renovations were recommended: repairing, replacing or adding ceiling beams (16 %), removing decayed ceiling and attic floorboards (21 % of cases), adding framing to improve the load bearing capacity of existing walls or supporting ceiling beams (18 %).

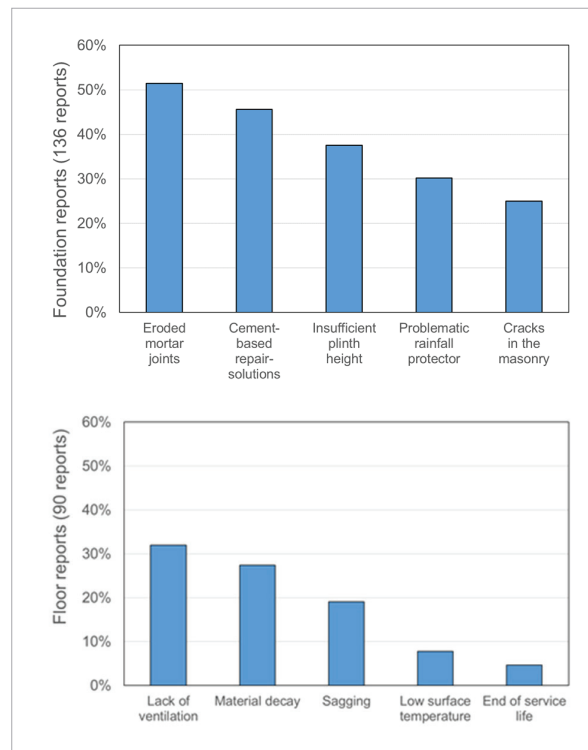
Fig. 5

The main damages present in consultation reports concerning foundations (above) and floors (below)

Recommendations for renovation works generally describe three options. Concrete slab on ground was the most commonly suggested solution (42 %), consisting of dry compacted subsoil, 100 to 200 mm of EPS or XPS insulation, a PE foil and a 70 mm concrete slab with floor heating (hydronic or electrical). An outdoor air ventilated floor on wooden beams was the second most common (23 %) renovation recommendation. Ensuring efficient ventilation between the floor and dry compacted subsoil was highlighted by consultants in order to avoid excess moisture due to evaporation from the ground. This solution poses risks, however, as without a ground covering or sufficient ventilation, rising relative humidity beneath the floor during warmer months might cause mould growth (Kurnitski & Matilainen, 2000). The third and least mentioned solution was an unventilated wooden floor, which described removing damaged floor beams and damp excess soil, building concrete pillars to support the wooden beams with a moisture barrier in between, and refilling the space with dry sand. This solution is likely to have the shortest service life and ought to not be recommended, as contact between soil and wood elements is still present and will likely lead to fungus growth (Mattsson et al., 2010).

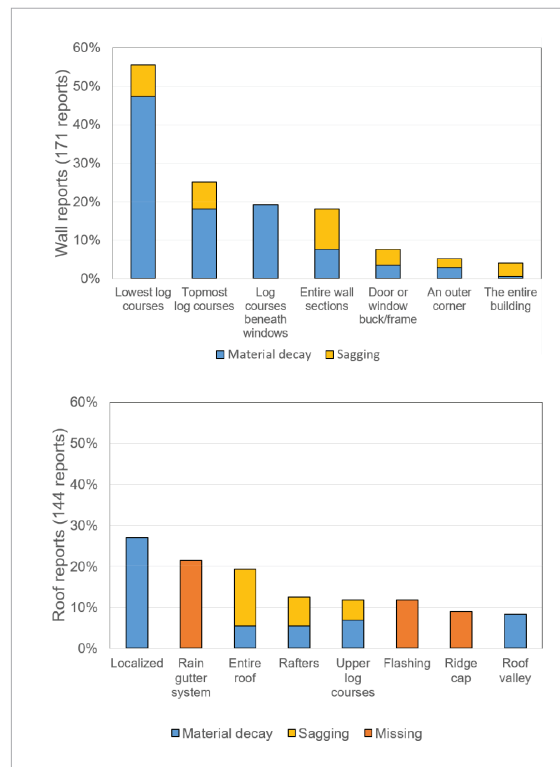
Fig. 6

Damaged or highlighted elements present in consultation reports concerning walls (above) and roofs (below)

A third of roof structures were deemed salvageable by replacing or repairing damaged or missing rafters or collar beams (31 %). However, a number of roof structures were declared beyond repair and an entirely new structure was recommended in 17 % cases. There were also examples where new roof coverings had been installed on faulty structures. Other recommended works included installing or improving rain gutter systems (20 %), repairing or installing missing flashes (10 %), installing snow guards, or general cleaning.
