Investigation of Width of Vertical Cracks in Reinforced Concrete Box-Girder Viaducts

The article examines the effect of dynamic loads on crack width of decks of prestressed reinforced concrete frame (box-girder) viaducts. The experimental measurement of the changes in width of vertical cracks of Pareizgupis viaduct resulting from the loads of moving heavy weight vehicles was made. During testing, four-axle vehicles with weights of around 40 tonnes were used and they were driven over the viaduct deck at the speed of 20–40 km/h. The stresses in prestressed reinforcement were analysed, calculated and compared to the results obtained during testing. Having evaluated theoretically the elastoplastic operation of concrete, the width of a vertical crack was measured in the middle part of the viaduct.

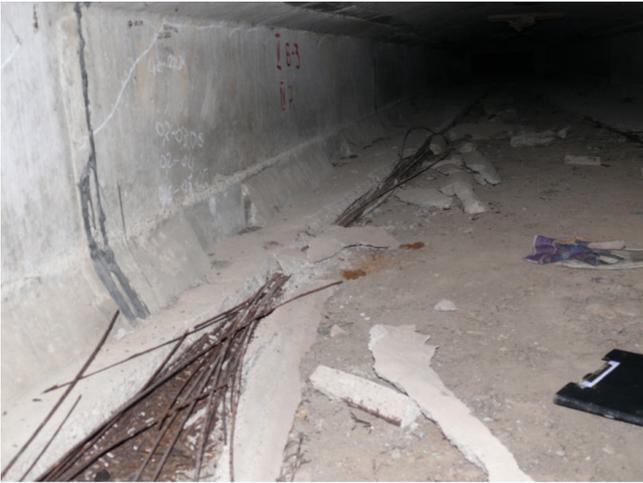
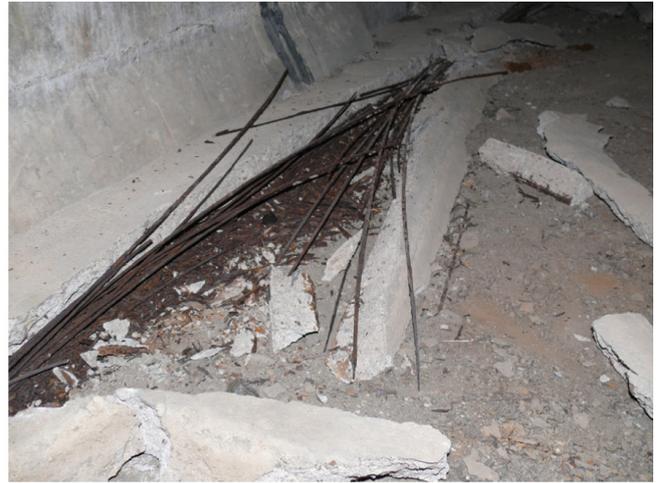
Fig. 3. The general view of corroded tendons in the location of opened vertical cracks

It was found out during the inspection of viaduct structure that stressed tendons were highly affected by corrosion and some wire bunches were broken in the 5th segment of girder "B" (in the location of vertical cracks) (Fig. 3).

There are 24 high-strength stressed wire bunches at the bottom of this girder with the total cross-sectional area of 113 cm². Having inspected in detail these wire bunches, it was determined that 2.5 wire bunches were broken and

2 wire bunches were greatly subject to corrosion and were released.

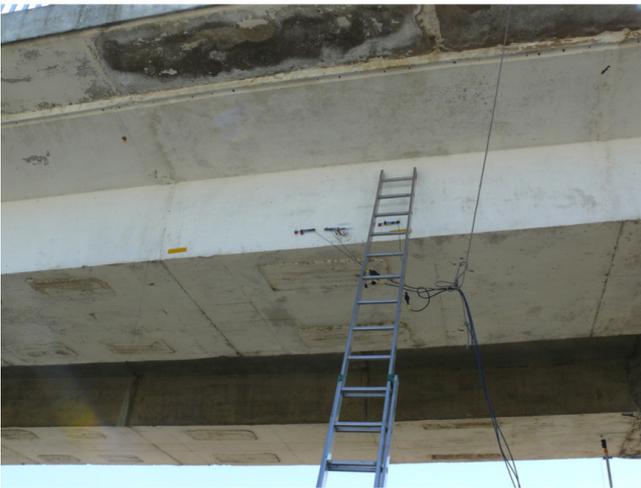
Fig. 4. Experimental measurement of the changes in width of vertical cracks

More than 300 heavy weight vehicles move over this viaduct per day and they affect corroded tendons additionally. In order to examine the effect of dynamic loads on the viaduct deck (especially in the cracked girder "B"), the changes in width of vertical cracks under the loads of heavy weight vehicles moving over a deck have been measured experimentally. Testing was conducted in April 2011. The changes in width of vertical cracks were measured in the place of stressed reinforcement by electronic and mechanical sensors (Fig. 4).

The widths of opened up cracks were measured before the arrangement of sensors: the width of the first crack was 0.35 mm (60 mm measurement base), the width of the second crack was 0.40 mm (35 mm measurement base), the width of the third crack was 0.50 mm (56 mm measurement base). The changes in width of viaduct vertical cracks were measured using a four-axle vehicle with the weight of around 40 tonnes and it was driven over the viaduct deck in the speed of 30 km/h. The experimental measurements of the changes in width of vertical cracks are presented in table 1.

The experimental measurements of the width changes of the second vertical crack were chosen for more detailed analysis of viaduct deck cracking. This change in crack width was measured by an electronic sensor and a mechanical indicator (precision of 0.01). They produced the same results.
