The Effect of  
Climate Change  
on Weathering:  
Evidences from  
Heritage Buildings  
under Subtropical  
Conditions

Journal of Sustainable  
Architecture and Civil Engineering  
Vol. 2 / No. 29 / 2021  
pp. 232-245  
DOI 10.5755/j01.sace.29.2.29425

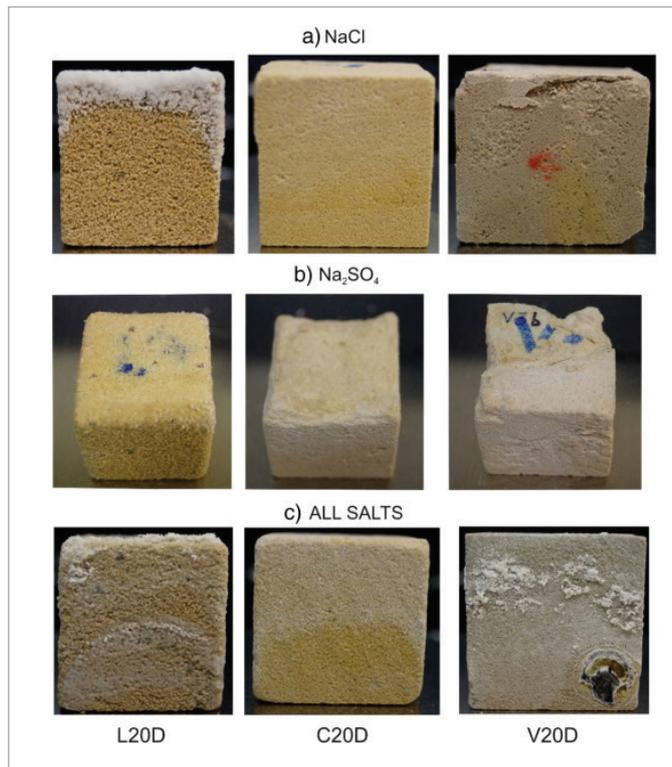
Fig. 1

Sample photographs from the experiment conducted by Menendez et al. on different kind of stones with 3 different weathering mediums a) sodium chloride, b) sodium sulphate and c) salt mixture at room temperature and low relative humidity. The formation of salts, delaminations and discolouring is visible on the specimen's surface (source: Menendez et al., 2016)

Another environmental factor affecting salt crystallization is the increased temperature (Fig. 1). Higher temperatures can result to higher amounts

of evaporation, resulting in the white cotton like formation of salts on the surface. In repeated cycles of this process, the surface of the porous limestone eventually delaminates and a honeycomb structure is developed in the worst-case scenario or at the best, the surface discolors with oxide stains (Menéndez and Petráňová, 2016) (Pan et al., 2019).

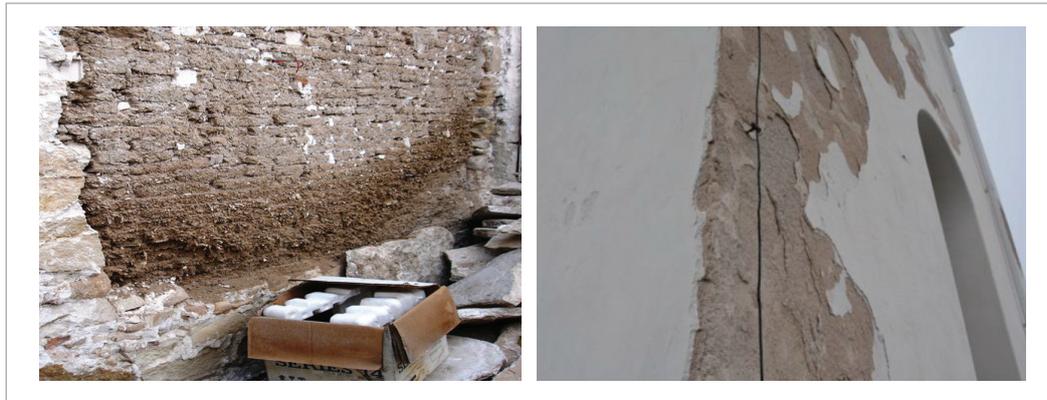
**Fig. 2**

Deterioration at the base of an adobe wall (left) and characteristic fissure on the upper part of an adobe wall caused by the action of rainwater (right) (Illampas et al., 2009). Each separate render layer spalled off was caused by freezing temperatures in a lean lime render saturated with water (Balksten et al., 2021)

All deterioration mechanisms are directly or indirectly water based. Upon absorbing water, building materials become saturated (Fig. 2). The presence of an incompressible medium like water in the pores of a material causes internal stresses which exert pressure against its bonds; this effect results to tension strains within the material. In cases that the tension capacity of materials is exceeded, cracking along the weaker sections of the material is caused (Schaffer, 2015). The effect is similar in freezing conditions, causing the absorbed water to frost and expand. The thaw-frost cycles can result to exfoliation, dislocations and milling of building elements and of their surface (Clim et al, 2016).

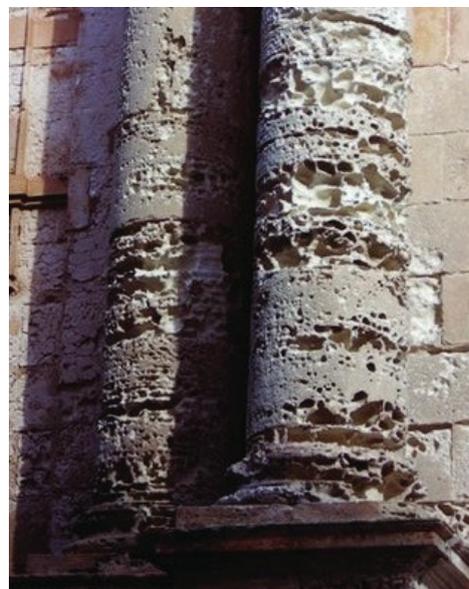
**Fig. 3**

Salt Crystallization-Weathering of Stone (Gupta, 2013)

Salt crystallization (Fig. 3) in limestone occurs when the absorbed water by the pores of a building material begins to evaporate. During the evaporation stage, the ions of building materials are pulled out of the porous and crystallize on the surface of the material. This effect is extended within the pores of the material as well. The effect results to the building material breaking up and smoothing out of its edges. While the pores of the material crystallize, they become oversaturated and internal stresses result to cracks (Angeli et al., 2007).

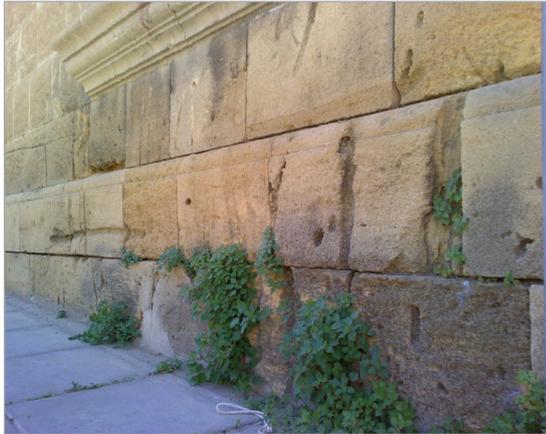
Fig. 4

Visible microbial growth

Biological degradation (Fig. 4) refers to the development of microorganisms and fungus at the mortar joints and the building material themselves. The microorganisms lead to the development of plantations that with the root develop-

ment due to the water cause the internal stresses to develop and destroy the bond between mortar-stone (Clim et al., 2016).

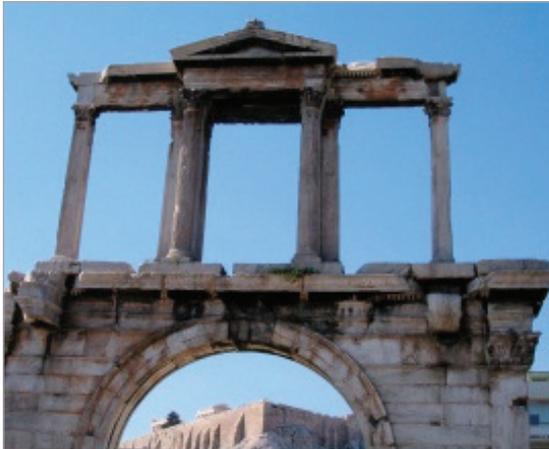
Fig. 5

Hadrian's Arch at the Acropolis, Athens, 2005, marble blackened and corroding from acid rain (Marcok, 2015)

Chemical deterioration of building elements refers to the chemical reactions that erode the stone facade of buildings due to processes like dissolution, hydrolysis and oxidation. The chemical reaction in this case, alters the composition of stones or acts at the surface level of the stone. This form of weathering is mainly attributed to air pollution, since the main chemical attackers are acid gasses, like carbon dioxide or acid sulphur. The acid gasses end up on the surface of heritage buildings through rain precipitation or winds, resulting to a black crust on the surface of the stones. Acids can further penetrate in building elements and result in their deterioration (Fig. 5) (Gupta, 2013).

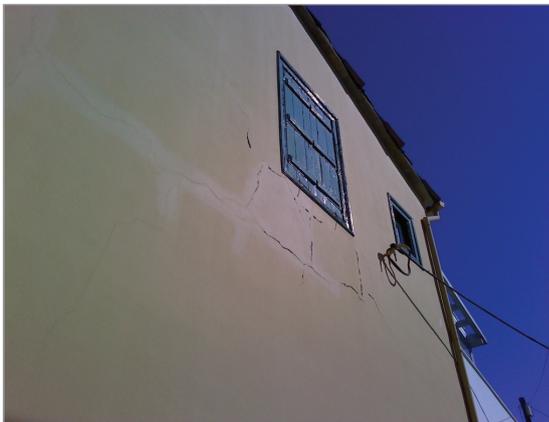
Fig. 6

Formation of Vertical cracks due to thermal expansion. Distinct characterization of thermal cracks is the thicker crack on one side that slims out further along

Weathering due to thermal expansion in buildings occurs regularly under sub-tropical environmental conditions. In terms of weathering mechanisms, along with rising damp, thermal expansion is one of the most important factors when it comes to accelerated weathering or normal pace ageing of a heritage building. The internal strain caused by thermal fluctuations in the building's materials during a day-night cycle can result to crack formation and propagation in buildings as shown in Fig. 6. The crack formations can lead to deterioration of the building element, by allowing water seepage during rainwater runoff and microbial growth in the cracks. Another result of thermal expansion in stones is the enlargement of the pores, which in return can be saturated with water due to minor cracks caused by the thermal cycle (Luque et al., 2010).

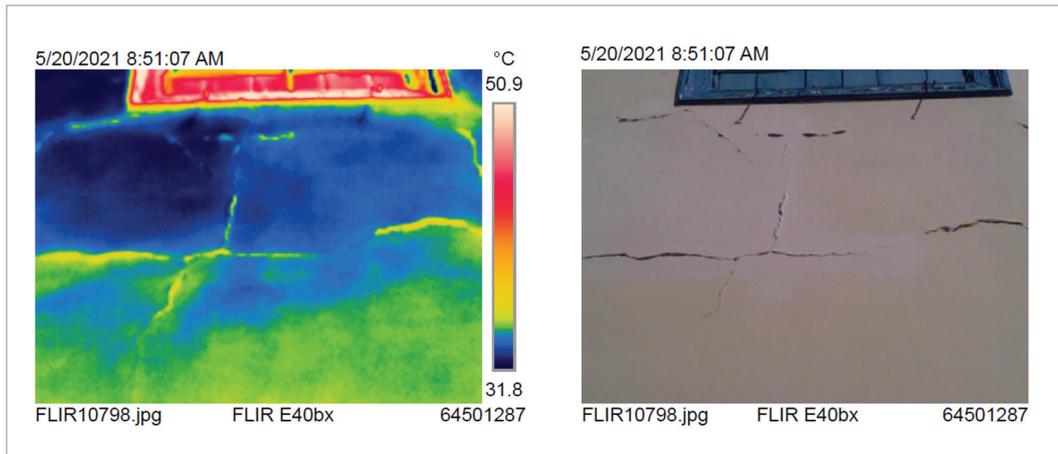
The thermograph presented in Fig. 7 is from Building 6-Plot 566 and was taken in February of 2021. It shows extensive crack formation below the window at the second floor level. The cracking is directly related to thermal expansion of the materials and this is a result of prolonged sun exposure and repeated temperature fluctuations. The orientation of the wall is South East, which translates to sun exposure from sunrise until midday with a total exposure everyday roughly for 7

Thermal Expansion-  
The masonry exhibits  
extensive cracking

hours during the summer season and 5 hours during the winter. This prolonged exposure means that the higher temperature reached for this masonry during peak exposure is very different from the lowest temperature that will drop to during the night time which causes the materials to experience thermal strains, resulting in crack formations.

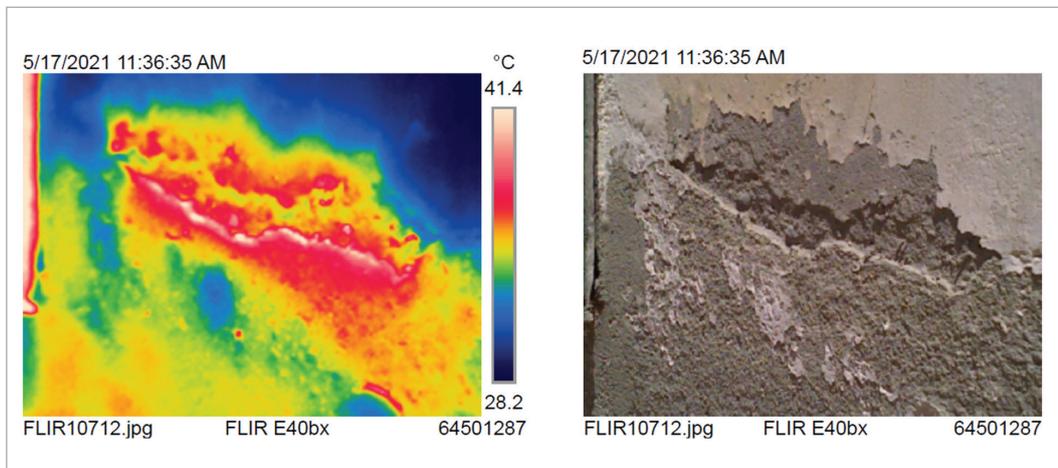
Rising Damp is the first and most occurring damage in all the in situ visits conducted. Rising damp is proven to be one of the main reasons of heritage buildings been crippled and damaged. In Fig. 8 rising damp is been observed in the masonry element which caused the plaster to develop internal stresses due to an incompressible medium like water which in returned, lead to crack formation. The surface layer of paint delaminates due to evaporation cycles of the water, which draws ions out of the masonry and into the surface of the plaster, which causes salt crystallisation. The surface of the plaster seems to be in a honey comb state due to the repeated cycles of water evaporation and salt crystallisation. In Fig. 9 the cycle is at a different pace from Fig. 8, the surface paint has delaminated and detached from the plaster underneath developing the “hills” and “valleys” on the surface of the asbestos based paint. Both thermographs are from Building 1- Plot 337 and are from a Southwest orientation taken in October of 2020.

Rising Damp  
damage

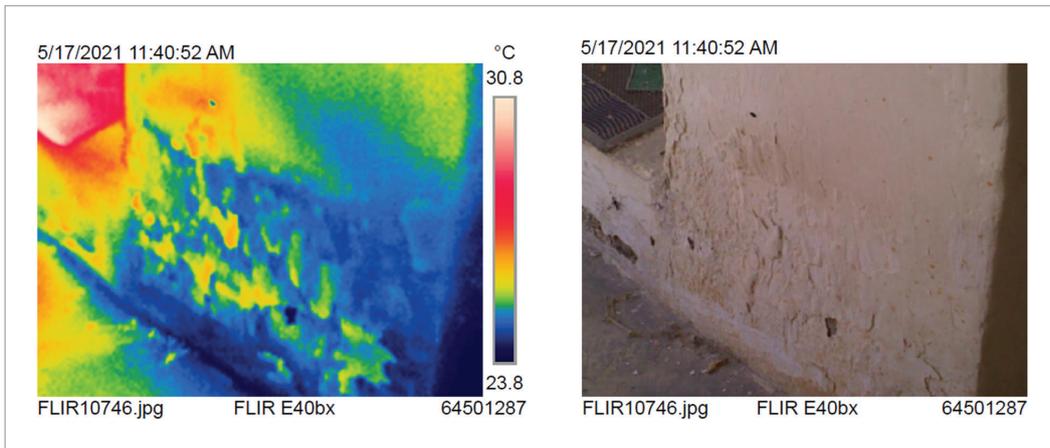
**Fig. 9**  
Rising Damp-Salt  
Crystallisation

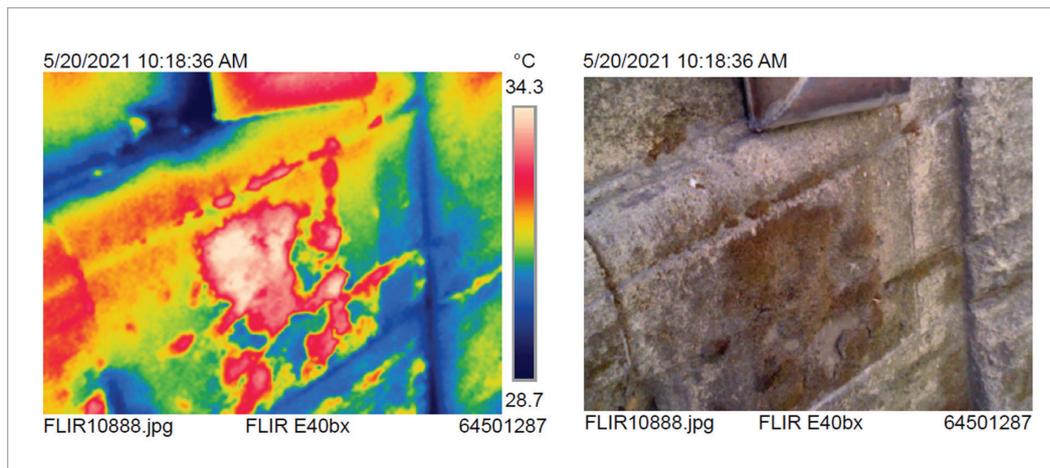
The following Fig. 10 and Fig.11 are from Building 4- Plot 230 and are North and West facing respectively and the in-situ visits were in November of 2020. The thermograph depicts the micro-

**Fig. 10**  
Fungi growth on surface  
of Stone

bial growth that follows the rising damp in masonry elements. Due to high relative humidity and warm environmental conditions, as well as the presence of moisture in building elements, fungus develops and grows on the surface of building shells. Depending on the type of fungi, they can be toxic and cause health problems to occupants after a prolonged exposure to their toxins. Plant growth in building elements can find root in cracks, voids or gaps in the mortar between stones. The plant development is based on wind transportation of the seeds or by adjacent plants to the walls themselves. The growth of the plants causes the mortar to delaminate and detach from the stones with the growth of the root system of the plantation that puts the bonds of the mortar under stress at the micro scale level.

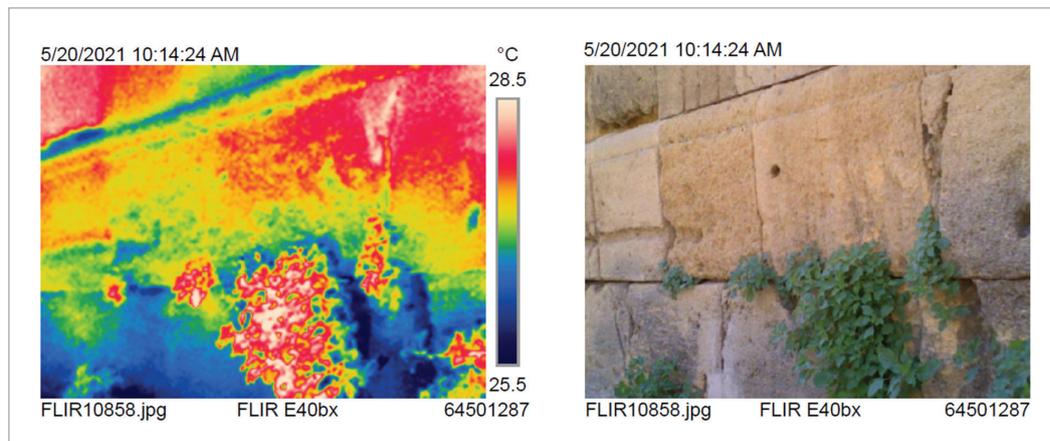
**Fig. 11**  
Plant Growth in gaps  
between the Stones of the  
Masonry

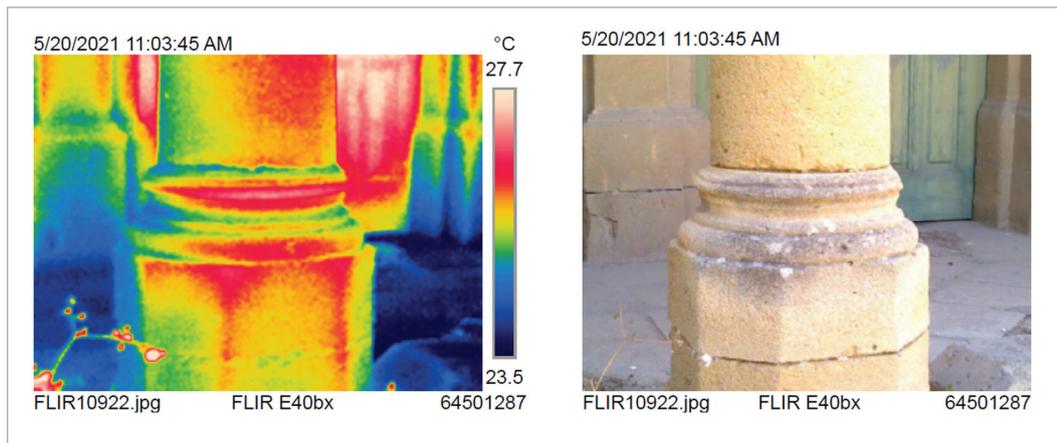
**Fig. 12**

The carbon dioxide deposition on building elements is a weathering mechanism requiring the chemical reaction of the two mediums, carbon dioxide and the building material (silica based materials). Carbon Dioxide is deposited mainly through two environmental mechanisms, primarily through rain washing the carbon dioxide out of the atmosphere and onto the building shells and secondly through wind gusts. The presence of Carbon Dioxide on buildings is observed through the accumulation of a blackened crust (Fig. 12 and Fig. 13) on building elements and is evident from the in situ visits; the accumulation tends to happen on horizontal surfaces, which is easier for the carbon dioxide to stick to. A deteriorated, deformed surface is left behind after the chemical bonding of carbon with silica materials takes place. The thermographs are from building 3-Plot 547 and the in situ visits were in November of 2020.

Carbon Dioxide accumulating on the stone column

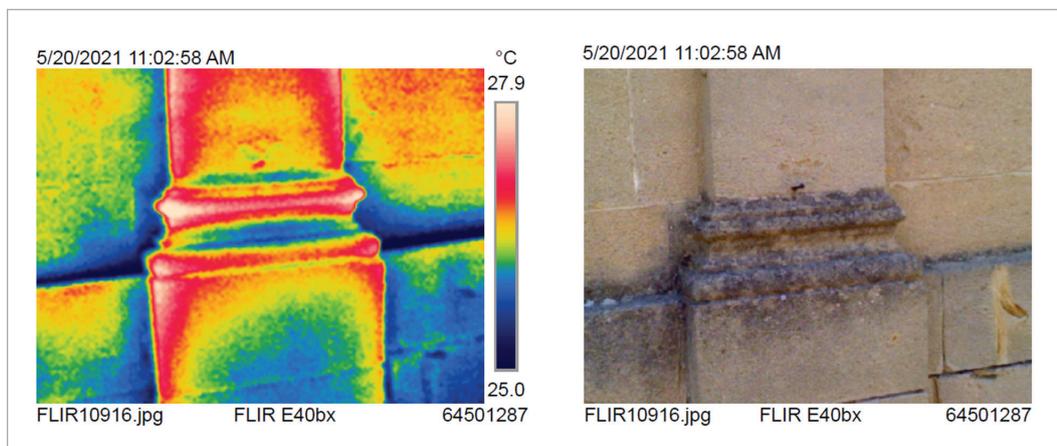
**Fig. 13**

Accumulation of Carbon Dioxide at the change of thickness in the material
