Towards Decreasing  
Encroachments on  
Conserved Historic  
Buildings, Users  
Participation as an  
Approach: The Case  
of Youth Center-  
Sebastia

# Towards Decreasing Encroachments on Conserved Historic Buildings, Users Participation as an Approach: The Case of Youth Center-Sebastia

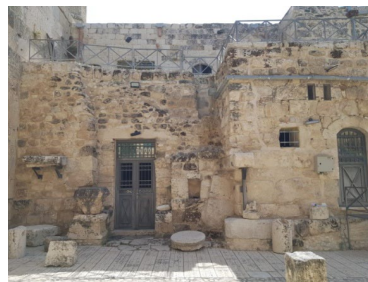
Fig. 2

Youth Center buildings (1-3), the alley (4), and the kitchen and bathroom (5)

A site plan of the youth-centre buildings

An illustration of building no 2

- Main building - Number 1: The building is composed of two floors: the ground floor containing two rooms that date back to the Crusader period, and the first floor, which was built in the late Ottoman period. It consists of two rooms in front of a balcony overlooking the outer yard on the western side. In the back (east side) lies a grove of trees and a concrete room used as a kitchen. To the south is a modern cement bathroom (Building 5). The ground floor was abandoned and was never used and is therefore currently in poor physical and structural condition. The first floor was used as a residence, making it in a better condition. The first floor was served by an outside concrete staircase (see Fig. 3).

- Second building - Number 2: It is composed of two floors with a rectangular footprint. The building was an abandoned residence and in poor physical condition before the beginning of the project.

- Third building (Taboon) - Number 3: It was originally used as a taboon, but was abandoned before the conservation process started.

The owner of the main building (Number 1 as shown in Fig. 2) rented out his building to Sebastia's municipality in a 13-year contract (1 May 2005-30 April 2018) rent-free to give the municipality a chance to save these buildings by conserving and rehabilitating them for public use. The owner received his buildings back from the municipality in June 2018 after the contract expired and the municipality was not interested in continuing to renting it.

1. Building 1: The building was used as the main building of the youth center, as one of the rooms on the ground floor was used as an administration office and one of the rooms on the first floor was used as a library/archive for documents that serve as a historical record of Sebastia. The other was utilized as a computer room. The two floors were connected by a spiral staircase which was added in the restoration process to serve the new population and the outside concrete staircase was removed.
2. Building 2: The ground floor (one room) was restored to be used as a multipurpose room for lectures and movie screenings (Fig. 2).
3. Building 3: It was used as a storage area for the other two buildings (Fig. 2).
4. The alley: Through the restoration process, it was cleaned and paved with stone tiles and seating areas were added (Fig. 2).

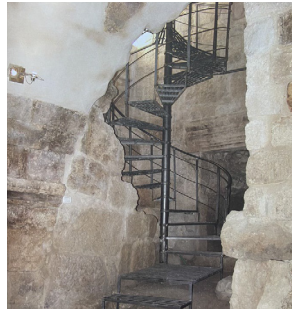
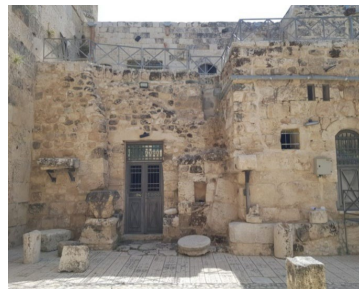
Fig. 4

Practices and interventions by the user (owner) on the youth center-Sebastia (building 1)

The spiral stair was installed in restoration building 1 (Benelli 2017)

The spiral stair was removed by user building no 1

1. Removing the internal spiral staircase by the user to split the two floors. building no 1

1. Partitioning the building into two separate floors: The internal spiral staircase that had connected the levels from inside was removed (Fig. 4:1). In its place, an external iron staircase from the middle of the alley to the first-floor balcony was added (Fig. 4:2) to serve each floor separately.

1. Random interventions: Interventions by the user that do not adhere to the standards of conservation, mainly reversibility, compatibility, and transparency. These interventions influence the historical value of the building and often lead to visual pollution (Fig. 4:1, 2).

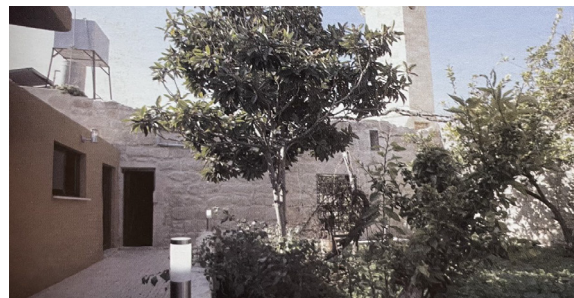
Before interventions by user building no 1

A new iron stair was added by the user building no 1

2. The user added a new iron staircase outside the building to serve the first floor

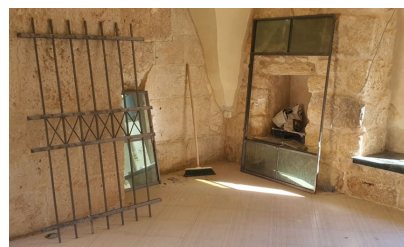
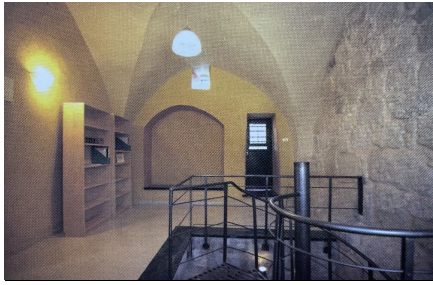
Window on the right side of the façade before dismantling it and replacing it with a door in building no 1 (backyard)

step 1: Dismantling the window protection and frame to open a door in building no 2

step 2: The window was removed and the door was installed in building no 2

3. Removing the window and the addition of a door to serve the room with the kitchen and bathroom in the backyard in building no 2

2. Separation of the two rooms on the first floor-: The owner separated the two rooms to rent out separately, though the bathroom and kitchen are shared by both. The kitchen and bathroom are located on the upper floor outside the building to the east (see Fig. 1). To implement this idea, the eastern window was removed and was opened as a door to provide access to the service facilities (Fig. 4:3). In the second room -where the spiral staircase had been- the owner covered the floor to use the entire area of the room (Fig. 4:4). This room has a door to the kitchen and bathroom on the east side. These interventions left the ground floor without a bathroom and kitchen, making it difficult to rent and the two rooms on the first floor in need of serious maintenance.
