Assessment of the Renovation Need, Material Authenticity, and the Cultural and Environmental Value of Historic Apartment Building Neighbourhoods

Journal of Sustainable
Architecture and Civil Engineering
Vol. 2 / No. 35 / 2024
pp. 53-67
DOI 10.5755/j01.sace.35.2.35747

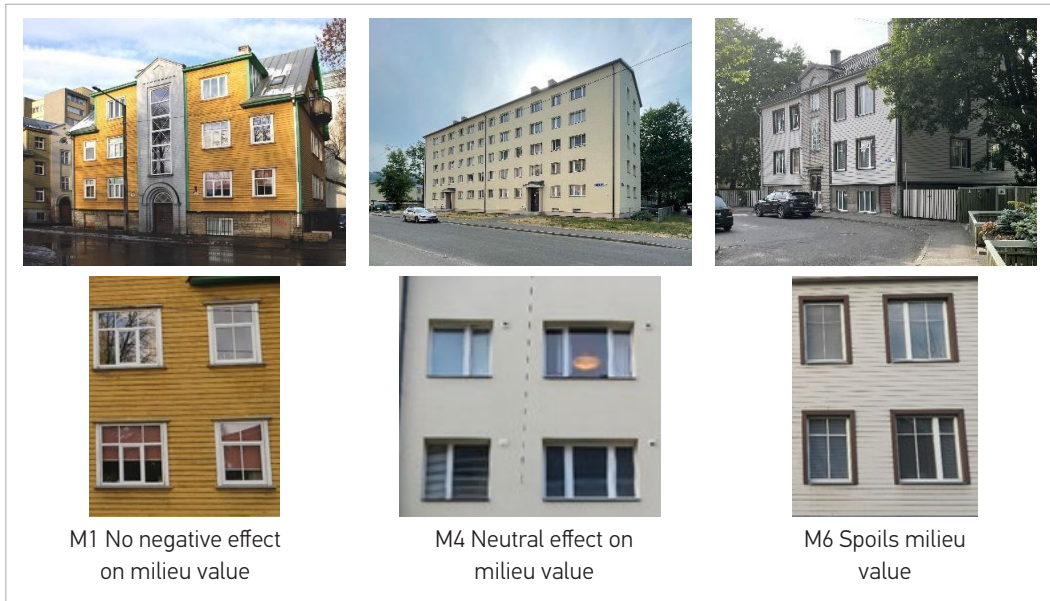
Fig. 1

Examples of the milieu value assessment of window materials

The milieu value assessment was based on the building component (see Fig. 1) and by considering the nearby buildings and area. Such an approach provided an overview of how the modification of the original substance has affected the aesthetical and technical situation in the milieu area. It also gives an understanding of how a single element could affect the impression of the whole and how many original/authentic materials exist today at all.

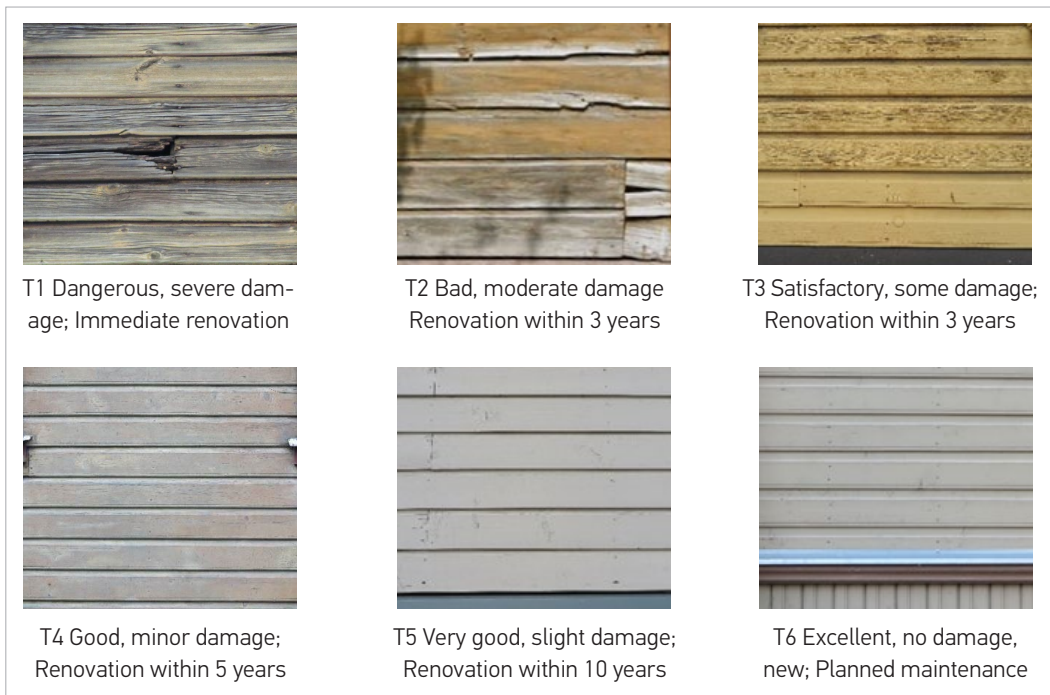
Fig. 2

Examples of the technical condition assessment of the wooden façade boarding

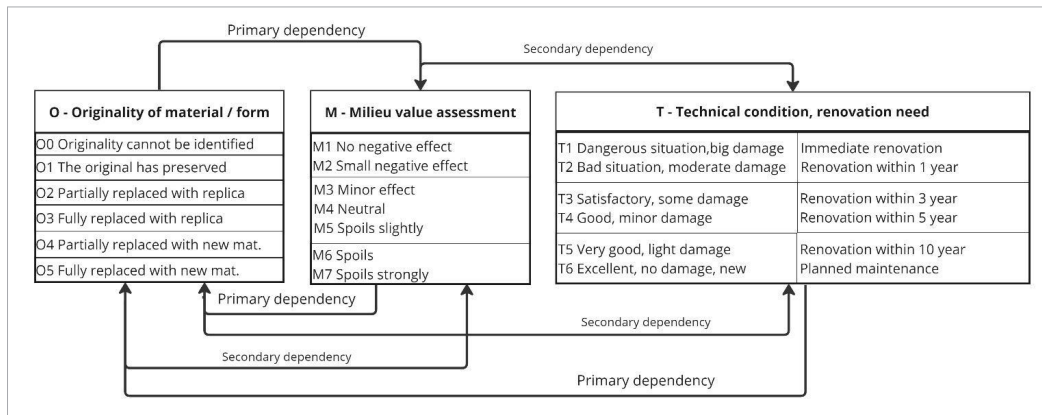
The evaluation topics, criteria, and primary and secondary dependency analysed

Responses were collected digitally using Google Forms and subsequently analysed by Grasshopper and MS Excel tools. Fig. 3 shows the evaluation topics, criteria, and the primary and secondary dependency. To find a causal connection, we performed a cross-analysis on three different dependency scenarios. Firstly, we divided the buildings according to the milieu value and studied how the authenticity of materials or form was evaluated (primary dependency) and then based on

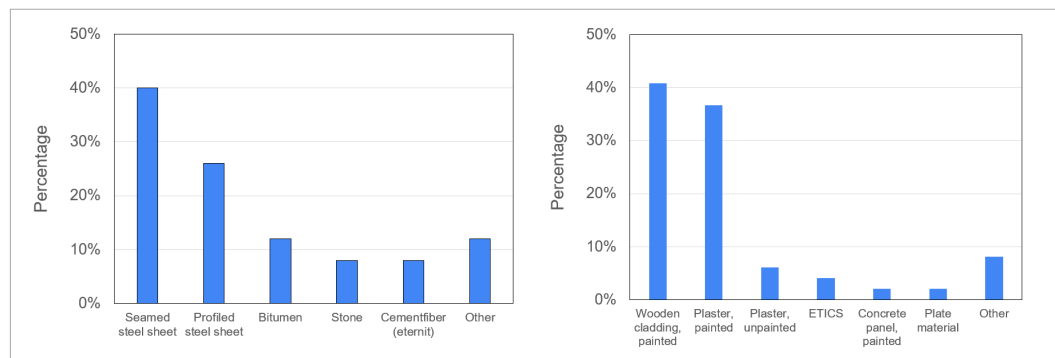
Fig. 4

Material of the roof (left) and the main façade (right)

The dominant roof material (Fig. 4, left) was steel sheet, with seamed steel (40 %) being the original, followed by profiled sheet (26 %) that is not allowed to be used in buildings built before 1940 (Tallinn, 2009). Other roof materials for pitched roof were stone and cement asbestos fibre board. Painted wooden boarding (41 %) and plaster (37 %) were the dominant façade materials. Plaster was the main (> 2/3) material also for plinth. Modern one-frame plastic was the main (51 %) material for window frame (Fig. 5, left), although it is forbidden to use plastic windows in buildings built before 1940 (Tallinn, 2009).

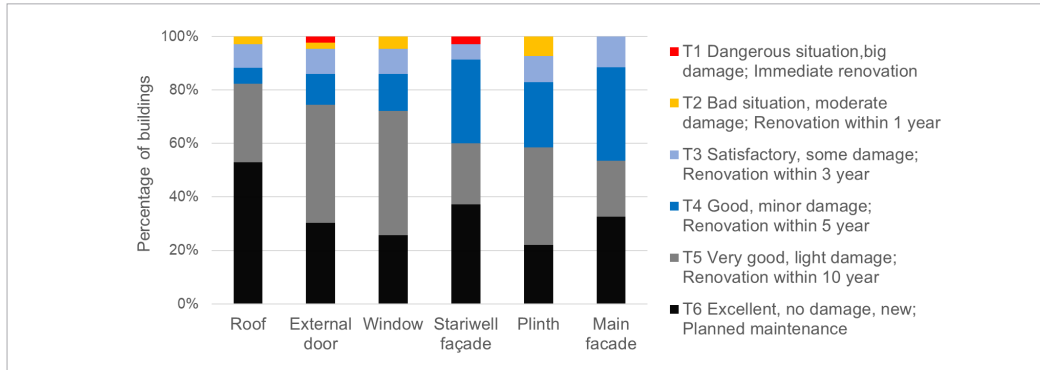
Fig. 6

Technical condition of the main building envelope exterior surfaces

In general, there were only a few buildings (4 %) in a hazardous or poor situation with considerable and moderate damage that required immediate renovation (T1 + T2), Fig. 6. The worst performing building component in this category was foundation plinth (7 %). Klõšeiko et al. (2011) studied 133 wooden apartment buildings in Estonia (a different sample compared to the current study) and showed that nearly a quarter of the investigated buildings needed immediate renovation and substantial investments to extend the service life and minimize the degradation. So, in more than 10 years, a lot has been done and the acute renovation need has been decreased. On average, 2/3 of studied apartment buildings were in very good or better condition with slight or little damage and will require renovation not earlier than in 10 years. Single building components with the best technical condition (T5 + T6) were the roof (82 %), window (72 %) and external door (74 %). This can

be justified by the fact that roof influences building durability and service life the most by protecting it from precipitation. Windows can be changed by the apartment owner and it requires no financial negotiation with the apartment association.

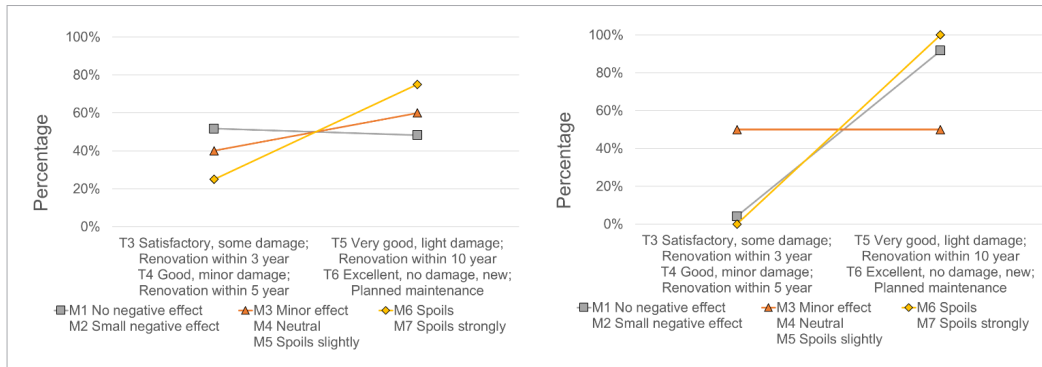
Fig. 7

The influence of material authenticity to the technical condition / renovation need of façade material (left) and roof (right)

Given that dangerous and poor technical conditions (T1 & T2) were rare, our comparison primarily focused on T3 & T4 and T5 & T6 technical conditions concerning the originality and authenticity of material and geometry. Specifically, regarding façade material, our hypothesis was confirmed: solutions that align with the milieu value (preserving originality) tend to be in poorer condition (due to age), while solutions that are neutral or detrimental to the milieu (newer) are more damaged (as illustrated in Fig. 7, left). Conversely, as to the roof material, which was mostly replaced (maintaining very good conditions) and has a limited impact on the milieu (not being visible from the street), our hypothesis was not substantiated (as depicted in Fig. 7, right).

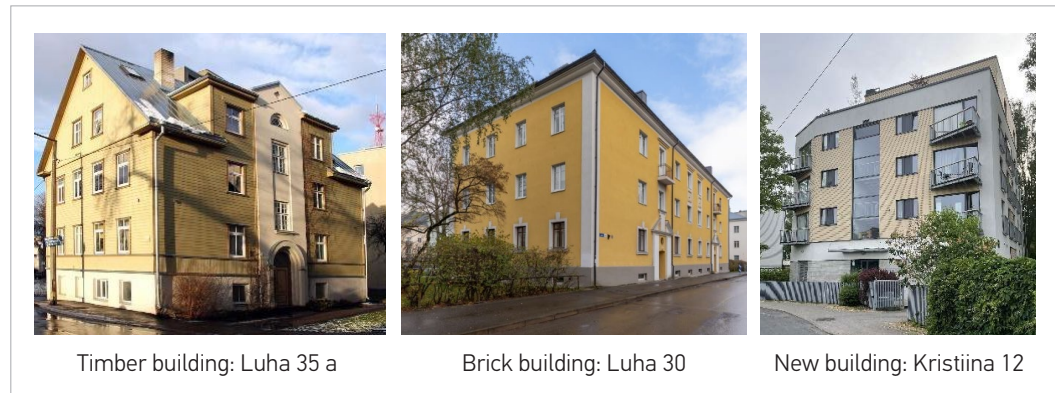
Fig. 8

Good renovation and construction examples from the studied Uus Maailm milieu value area

Analysing all the building parts together, three buildings were drawn out with their suitability for the milieu and the excellent technical situation (see Fig. 8). The comparison of the relationship between the milieu values and authenticity reveals that the relationship between the geometry and material of building parts generally follows the same trend, for example, when looking at the graphs of the stairwell door awning and plinth sills. This can lead to the conclusion that building parts have been renovated or altered at a similar pace and it is possible to keep the geometry as it was when the building was originally built. In most cases, the original solution has always been better from the perspective of milieu value. It is only in case of window materials and finishes that there are more replica solutions than original ones that do not disrupt the milieu value.
